JOINT TASK FORCE ONE

ARMY GROUND GROUP
(TASK GROUP 1.4)

FINAL REPORT

ATOMIC BOMB TESTS

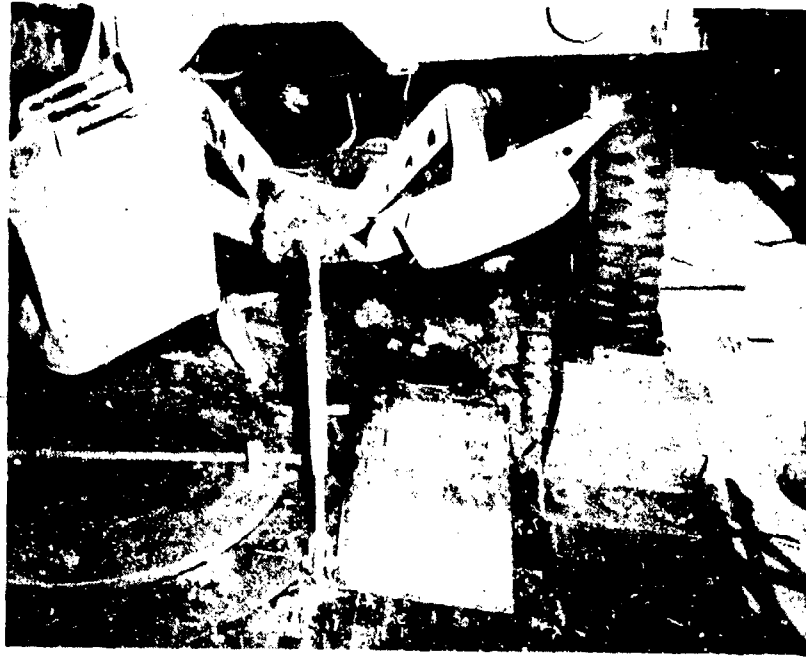
Fig. 73 - USS Arkansas - Truck, 1/4 Ton, 4x4.

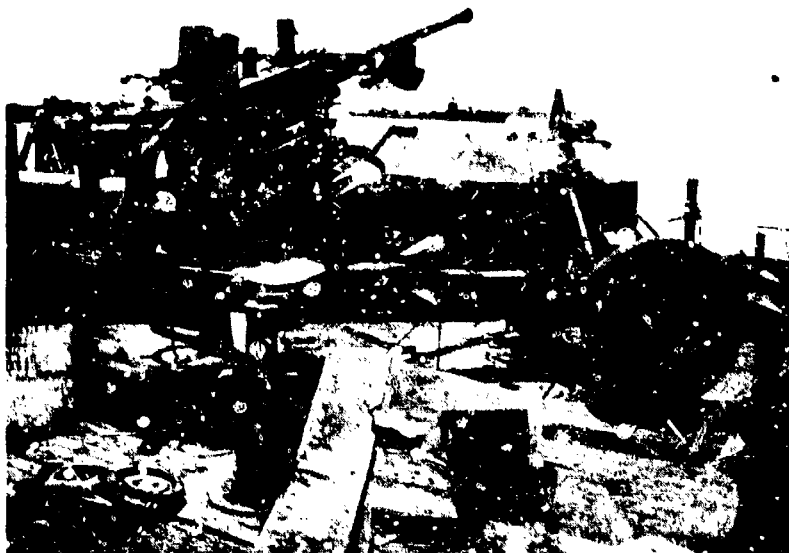
a. The item displayed on the USS Arkansas was entirely masked from the bomb. All damage was secondary, caused by flying or falling debris. Damage consisted of: misalignment of rubber covered coupling in the horizontal shaft to the elevating power unit, and loosening of all holding bolts permitting movement of the elevating power unit; right rear platform bent downward; bent traversing and elevating operator's seats, caused by pressure; and missing hood and shield assemblies. Manual elevating and traversing was satisfactory, as was operation of the rammer, breech block, and firing mechanism. The materiel was quite dirty on the exterior. All preservative materials in the tube, breech, rammer and elevating rack were examined, visually and by feel and apparently suffered no breakdown. With slight straightening and cleaning the materiel could go into immediate combat. The power elements of the carriage were not operated because no director or generator was available. While the power elevating mechanism could operate through the bent coupling mentioned above, it would be inadvisable. For hand operation the coupling could be disconnected. A wooden splinter approximately one inch in diameter was found imbedded in the sidewall of the right front tire, see Fig. 79. The deck around the gun carriage showed no evidence of scorching and none was present on the materiel. The peep sight on the elevation side of the Computing Sight, M7A1, was made unusable by the linkage breaking on that side, see Fig. 80. The azimuth side ring sight was bent backward, see Fig. 81. The super elevation linkage was bent and the deflection linkage broken, see Fig. 80. The arrow on the computing mechanism jammed at "0" azimuth and the deflection computing mechanism jammed at 75 mph.

Fig. 79 - USS Arkansas - Carriage, 40mm, AA, M2A1 -
View of deformed platform and operators seat.
Note wood imbedded in right front tire side wall.

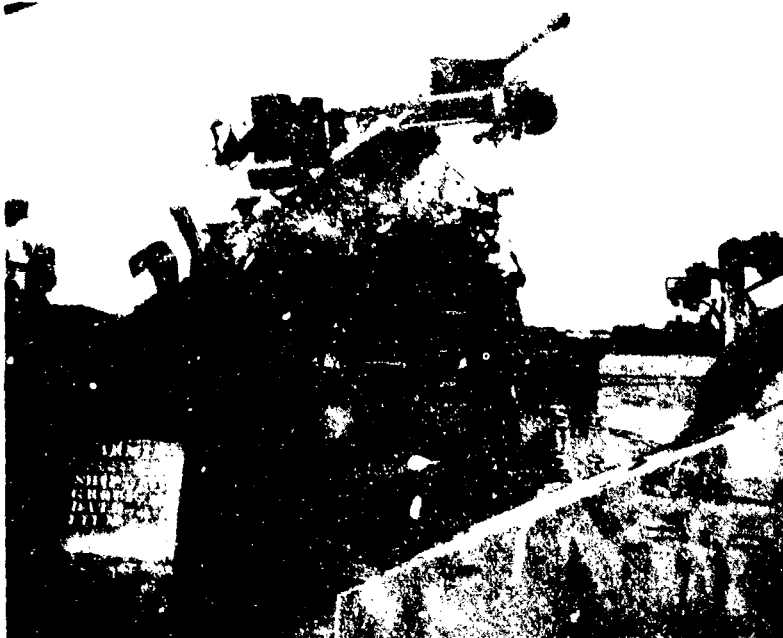
b. Like the USS Arkansas, the materiel on the USS Nevada was entirely masked from the bomb. Most damage was secondary caused by flying debris. Damage consisted of: badly deformed traversing and elevating operators' seats, caused by pressure; bent vertical shaft universal joint below the traversing gear box; bent case trough; bent motor switch linkage; bent elevation limit switch; bent elevating handle; bent slewing handle frame; and missing hood and shield assemblies, see Fig. 82 and Fig. 83. Manual elevating and traversing was satisfactory as was the operation of the rammer, breech block, and firing mechanism. The materiel was quite dirty on the exterior. All preservative materials in the tube, breech rammer, and elevating rack were examined visually and by feel and apparently suffered no breakdown. The preservative in the bore and Breech Gun Casing particularly was in good condition. With slight straightening and cleaning this material could go into immediate combat. The foregoing statement refers only to the mechanical operation of the weapon. No director or generator was available to test the power operation, but no damage to the hydraulic elevating or traversing equipment was noted which would indicate malfunction on their part. The ring sights of the Computing Sight, M7A1, were twisted out of alignment, see Fig. 84. Moisture was found between the field and eye lenses of one of the M7 telescopes making it unserviceable and the eye lens of the other was chipped. The latter however was still serviceable.

Fig. 82 - USS Nevada - Carriage, 40mm, AA, M2A1 -
Right rear view showing bent case guide and
traversing operating handle. Note sheet metal
debris wrapped around breech casing.

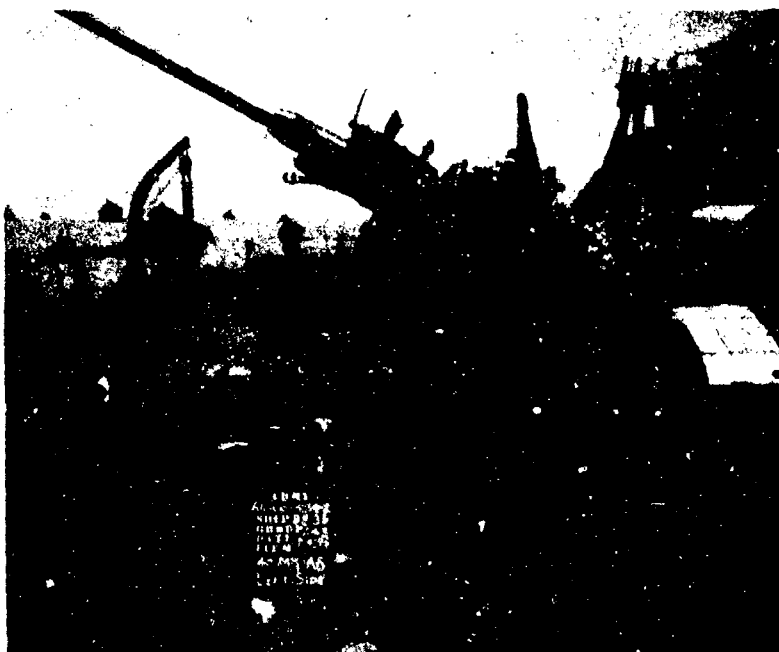
Fig. 83 - USS Nevada - Carriage, 40mm, AA, M2A1 -
Left side view showing bent operator's seat.

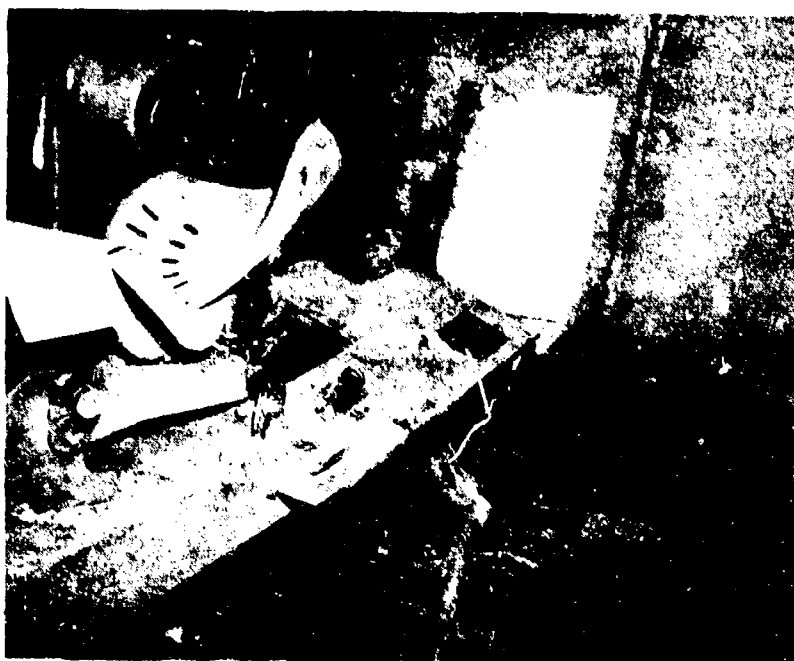
a. On the USS Arkansas the materiel was directly exposed. The force of the blast traversed the mount 45 degrees from the original position. Damage sustained included: deformation of the right front floor plate; the elevation operator's seat; the right splinter shield catch broken; and the light metal cover, over the oil level indicator of the elevation power unit, blown directly upward, see Fig. 85. Operation of the top carriage was hampered by the dials of the elevating and traversing indicators which were blown inward, partially jamming the gearing. Sufficient operation in elevation, depression, and traverse was done to indicate that no malfunction is present in manual operation. The breech block and firing mechanism functioned satisfactorily. Neither the fuze setter rammer nor the power elevating and traversing units were operated because a serviceable director and generator were not available for the test. The deck around the item was charred to a depth of 1/32". The paint, on the right and front splinter shields, top and side of the tube facing the blast, was discolored a reddish brown. The preservative on the elevating rack and on exposed surfaces of the breech ring breech block and fuze setter rammer was burned off but that in the chamber and tube, tested visually and by feel, had apparently suffered no breakdown. The materiel could be fired and maneuvered by manual operation, after removal of the indicators. A pint of recoil oil was drawn from the recoil mechanism for chemical analysis. Damage to Fire Control materiel included the elevation telescope mount bracket of the Sighting System, M7, bent inward at the top and the forehead rest bent inward and down, see Fig. 86. The lower part of the elevation Telescope, M60 was twisted, the reticle cracked, and the filter adapter bent. The instrument was not repairable. The cover glasses of the Indicator Regulators, M1, were smashed inward against the dials, bending the latter, see Fig. 87, Fig. 88, Fig. 89 and Fig. 90. When the gun was manually traversed and elevated, the bent dials caught the spiders, twisting them beyond repair, see Fig. 91, Fig. 92 and Fig. 93. The orienting wheels were jammed.

Fig. 85 - USS Arkansas - Mount, Gun, 90mm, M2-
Deformation of elevation operator's seat,
floor plate, and breakage of side shield latch catch.

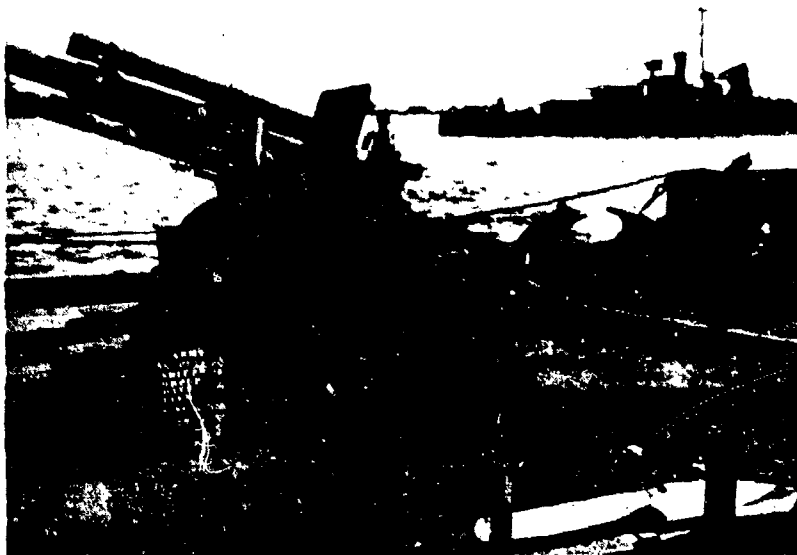
b. The Howitzer as displayed on the USS Nevada was pointed almost directly at the point of detonation with no masking whatever, see Fig. 100 and Fig. 101. The only damage was failure of the lower splinter shield and the hinges holding it to the frontal shield, and misalignment of the top shield prohibiting elevation above 430 mils, see Fig. 102. The preservative was burned off the traversing and elevating racks, exposed sleigh sliding surface, and for approximately two inches within the muzzle end of the tube but only where the heat could contact the interior of the tube without masking. The remainder of the preservative within the tube, chamber, and breech sliding surface was tested visually and by feel with no evidence of breakdown noted. The preservative on the equilibrator spring, masked under the carriage, was smooth indicating surface heating. All tires were inflated. Functioning tests of elevating, depressing, traversing, operation of the breechblock and firing mechanism disclosed no malfunctioning. The recoil mechanism was not gymnasticated nor manometer tested. The scale of the Panoramic Telescope, M12A2, was scorched to the point of illegibility and the reticle tilted. The field lens of the Elbow Telescope M16A1C showed separation. No damage occurred to this materiel on the USS Pennsylvania or the USS Saratoga.

Fig. 101 - USS Nevada - Carriage, Howitzer, 105mm, M2A1 -
General side view after Test.

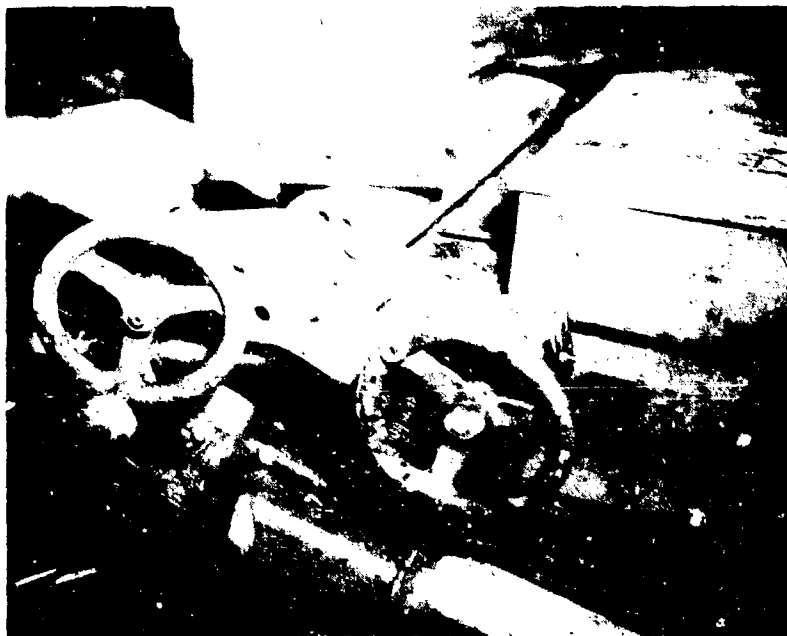
b. Damage to the Launcher, approximately 60% masked, on the USS Nevada was practically identical with that experienced on the USS Arkansas. The elevating mechanism was damaged beyond efficient operation when three 1/2" bolts anchoring the elevating mechanism to the bottom carriage were sheared, see Fig. 104. The accessories box installed on top of the tube nest was deformed by pressure, as shown in Fig. 105. The left trail tie rod was broken immediately forward of the turnbuckle, exactly where the tie rod on the USS Arkansas broke, and appeared to be a tension break at the weld, caused by deformation of the deck. The tires were inflated. The paint was slightly scorched. The damage to Fire Control Components was limited to a broken wire on the extension light of the sight mount.

Fig. 104 - USS Nevada - Launcher, Rocket, 4.5", T66E2 -
Detail of failure to elevating and traversing
mechanism bracket.

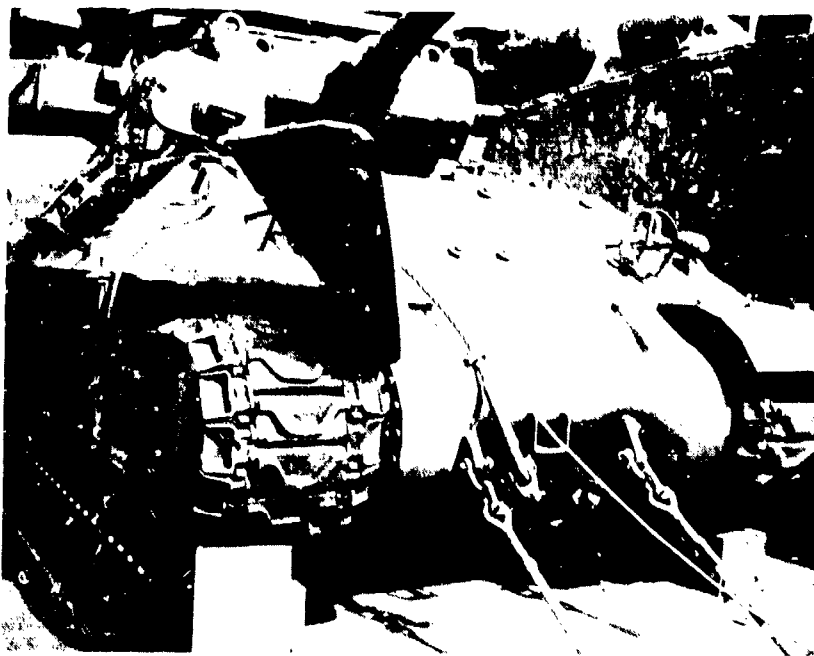
The ship's starboard anti-aircraft partially shielded this vehicle aboard the USS Arkansas. The paint on the right side was discolored reddish brown and black. This was only a surface discoloration since a light scraping uncovered the original color. The right fender was blown upward and torn loose across the hinges by the blast, the assistant driver's hatch cover was found open. The driver's cover had apparently been blown open and then fallen back into position with the latch outward preventing the hatch from closing, see Fig. 111. The lower periscope head at the driver's seat had fallen from its mounting and was found unbroken slightly ahead of the driver's seat. The upper section of the aerial was broken off, twisted and driven into the wood deck, three feet ahead of the right track. The lower section of the mast, held at the base but twisted under the open hatch on that side. The outer and right turret covers were torn loose and carried away, the two 3" hinges on each was torn loose at the weld. The left lid was blown open and was laying forward on the immovable part of the turret cover. The gun in the turret was elevated and traversed, no malfunction was evident.

Fig. 111 - USS Arkansas - Carriage, Motor, 90mm Gun M36 -
View after Test Able.

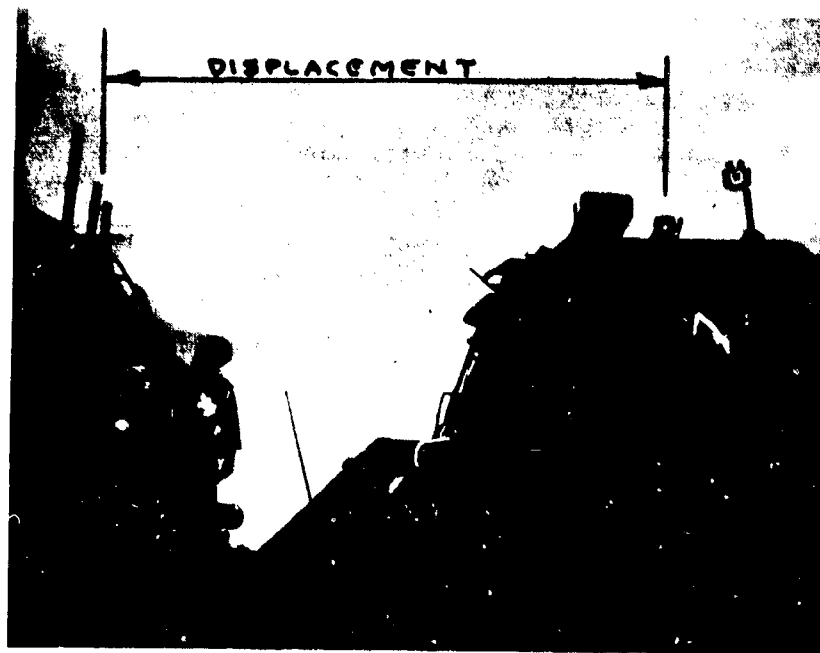
a. The Cal..50 Browning Machine Gun carried in the anti-aircraft position on this Gun Motor Carriage was lifted with its cradle and deposited on top of No. 1 gun turret. An idea of the distance the gun was carried may be seen in Fig. 112. The pintle from which the gun came may be seen at the upper right, see arrow, while the gun itself is being pointed to. The gun was undamaged except for a burr on the muzzle end of the barrel. The tripod usually stowed on this vehicle was parted from its remaining straps and struck the side of the same gun turret. The right leg was dented and both leg locks were bent. There was also a definite gouge in the pintle hole.

Fig. 112 - USS Arkansas - Carriage, Motor, 90mm Gun, M36 -
View showing dislocation of Browning machine gun
from mount on vehicle turret. Note arrow.

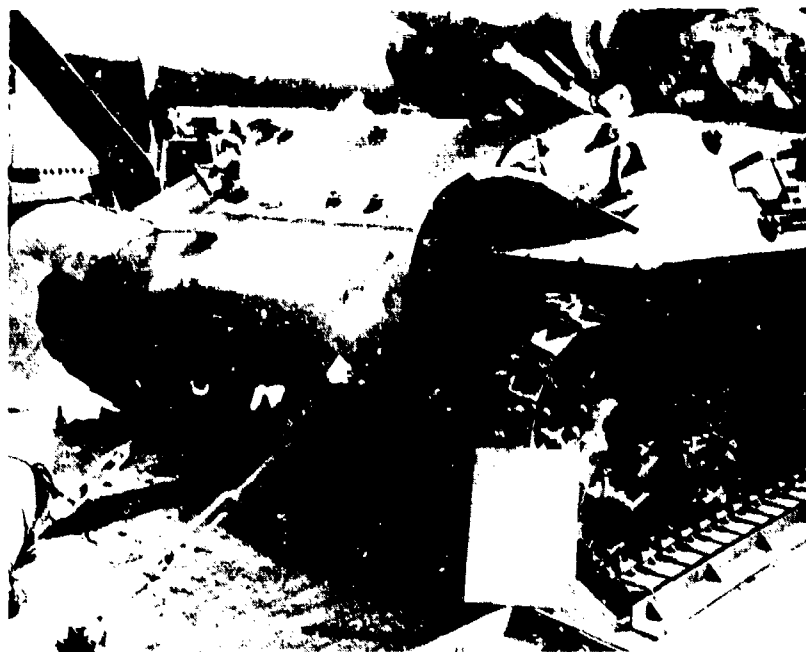
b. Aboard the USS Nevada, the left front fender was torn loose at the hinge similar to that aboard the USS Arkansas, see Fig. 113. The turret cover lids were torn loose, see Fig. 114, as on the USS Arkansas and the braces torn loose, see Fig. 115 and Fig. 116. The driver's hatch had blown open and in falling back was caught by the periscope head, see Fig. 113. The turret splinter shields on the right and right front were forced upward, see Fig. 115. The oil bath air cleaner hoses in the engine compartment were collapsed by pressure, see Fig. 117. A slight scorching was evident and the turret elevated and traversed satisfactorily. The Cal..50 Browning Machine Gun on this Gun Motor Carriage was struck by some falling debris on the barrel supporting bearing in such a way as to make it impossible to retract the firing mechanism freely. After removing the barrel, the gun mechanism functioned satisfactorily. One of the holding pawl springs was lost and the hood on the front sight was bent as if hit by some small object.

Fig. 113 - USS Nevada - Carriage, Motor, 90mm Gun, M36 - Condition after Test Able.

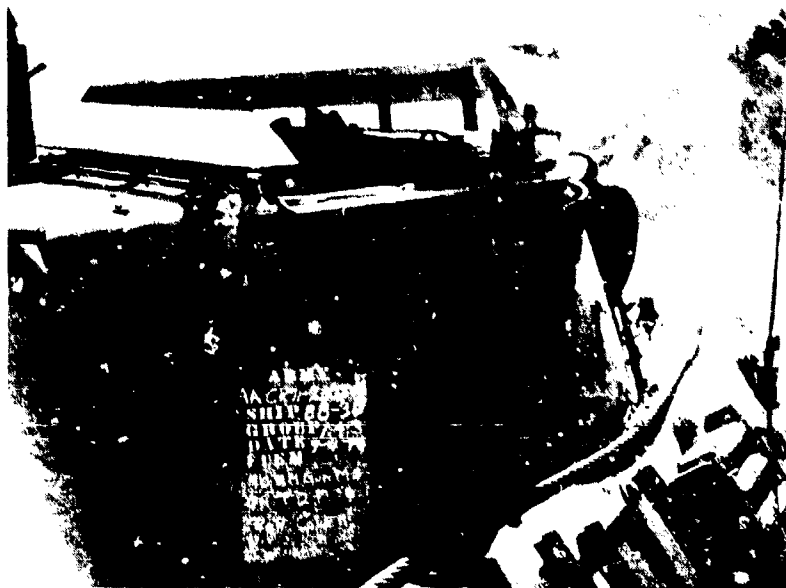
Fig. 116 - USS Nevada - Carriage, Motor, 90mm Gun,
M36 - Condition after Test Able.

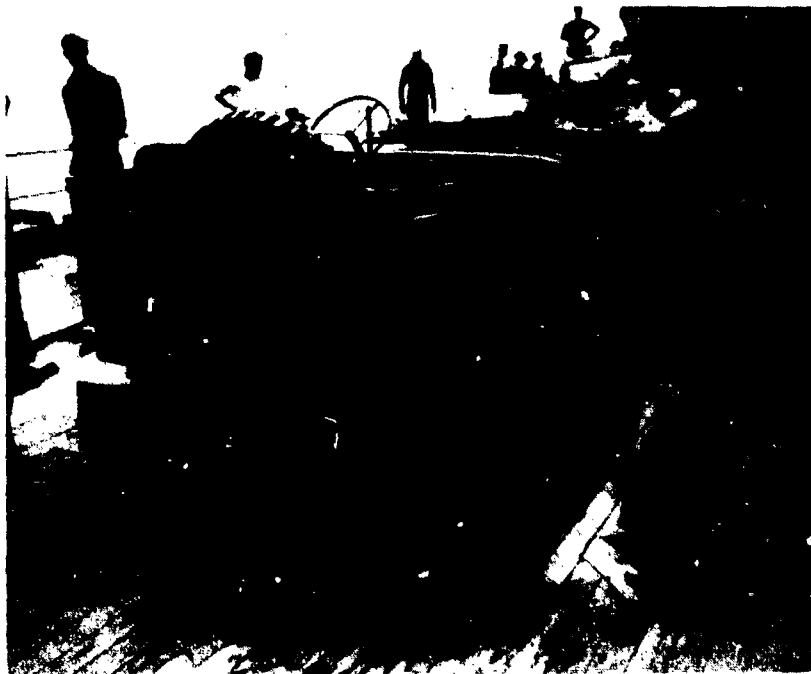
Fig. 127 - USS Arkansas - Truck, 1/4 Ton, 4x4 - View of lashings to right rear safety chain eye before Test Able.

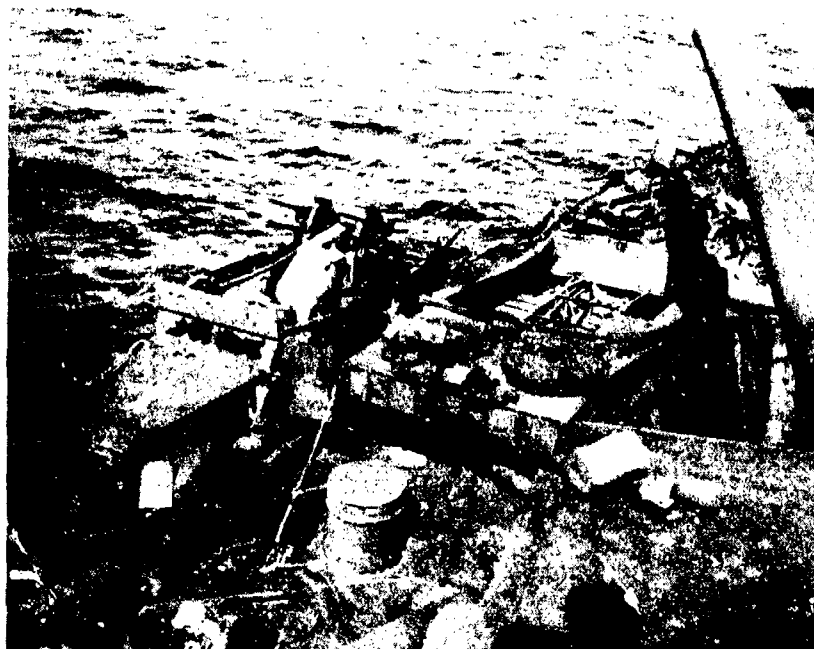
Fig. 134 - USS Arkansas - General view after Test Able, showing Carriage, Motor, Multiple, Gun, M16 and Truck, 2 1/2 Ton, 6x6, Amphibian.

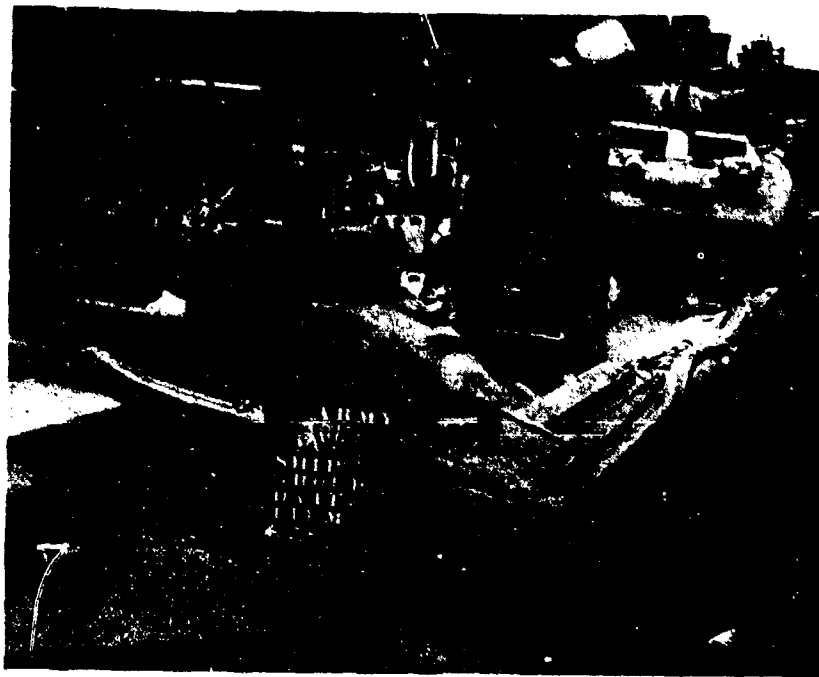
beyond repair, see Fig. 156, Fig. 157 and Fig. 158. In this report the correction panel which faces the rear of the trailer, will be considered as the front of the computer. The blast struck the top, rear, and right sides. All four covers were torn from their fastenings, one being carried 30 feet from the trailer. The top was partially torn free and crushed inward, see Fig. 158. The complete unit was twisted, bent, and torn from the shock mounting, and the shock mounting torn from its clamps. The clamps were bent and broken. The computer frame was bent at the front left corner as though it had struck the side of the lower trailer body, see Fig. 158 and Fig. 159. The adjustment panel was blasted inward, the meters blown from it and smashed and the switches rendered inoperable, see Fig. 160. A large number of amplifier units were twisted and torn from the frame. A few vacuum tube receptacles were cracked and twisted. Those few vacuum tubes that were broken were crushed by the twisting of the computer frame and the resultant shifting of component units. Vacuum tubes withstood the blast and subsequent testing revealed no internal damage. Some wiring was broken due to units shifting. The servo oil levels were slightly low but no leaks were evident. Although the computer was unserviceable as such, the majority of its component units were individually undamaged. See Fig. 159, Fig. 160, Fig. 161 and Fig. 162.

Fig. 157 - USS Arkansas - Director, M9A2 - Left front view after Test Able.

(5) Trailer M14 - The trailer body was irreparably damaged. The frame, wheels, axles and towing rig were undamaged. The trailer body above the basic lower section was ripped off and deposited in a mass, Fig. 156, Fig. 157 and Fig. 166. Although the leveling jack pads were welded to plates bolted to the deck, the trailer was skidded almost 3 inches to the right, compressing the tire side walls on the side. The jack legs were bent but the operating mechanism undamaged. The lower trailer body was blown to the right as may be seen in the above photographs. The interior lighting and heating systems were demolished as a result of the crushing of the body. The running lights were undamaged.

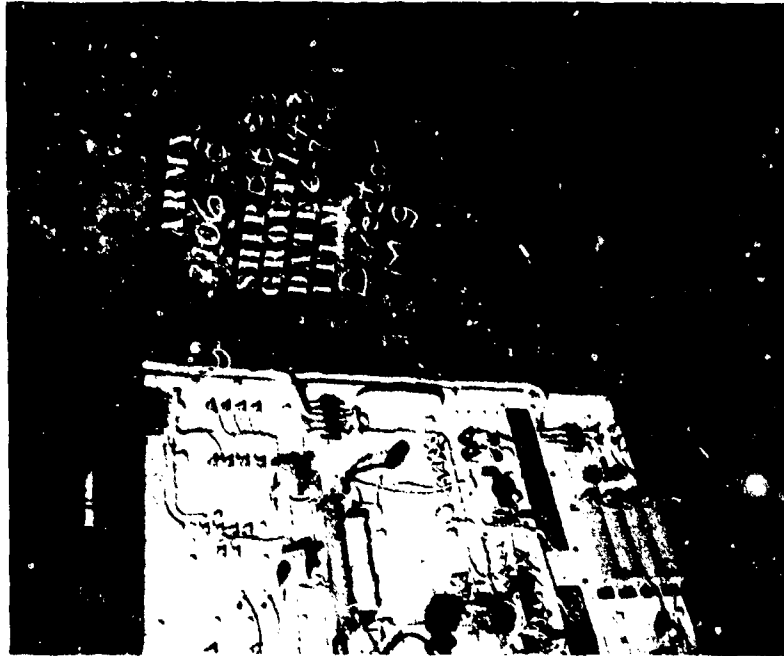
(3) Power Unit M3 - The cover and the top were blown off. The left side was crushed inward smashing the 2740 and 393A tubes and three tube sockets, see Fig. 163. The unit was torn from its shock mounting, but the shock mounting remained clamped to the trailer floor. The transformer unit on the right was torn from the frame

Fig. 163 - USS Arkansas - Power Unit, M3-
Left side after Test Able.

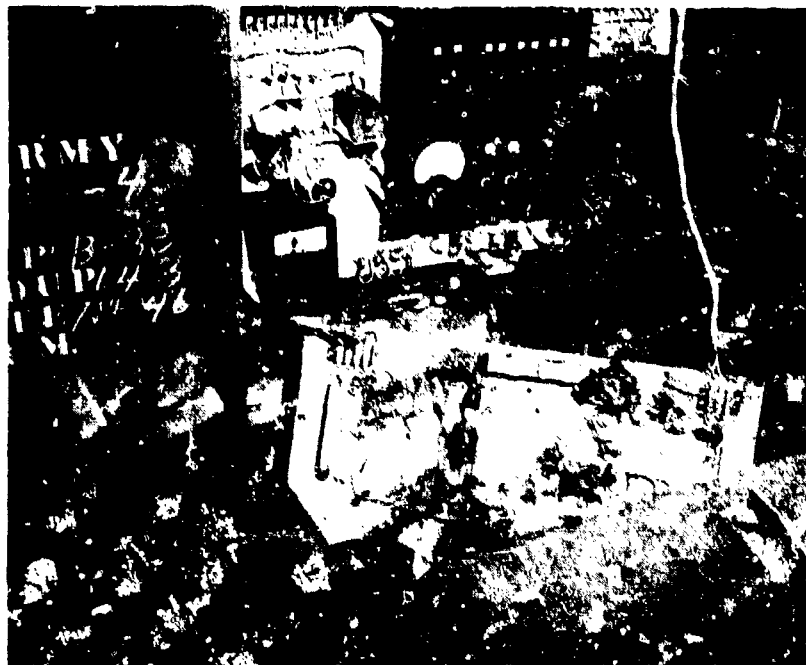
and left hanging by the wire leads, several of which were broken. A 393A thyratron tube on this unit was shattered, see Fig. 164.

Fig. 164 - USS Arkansas - Power Unit, M2 - Right side view after Test Able showing displacement of transformer unit.

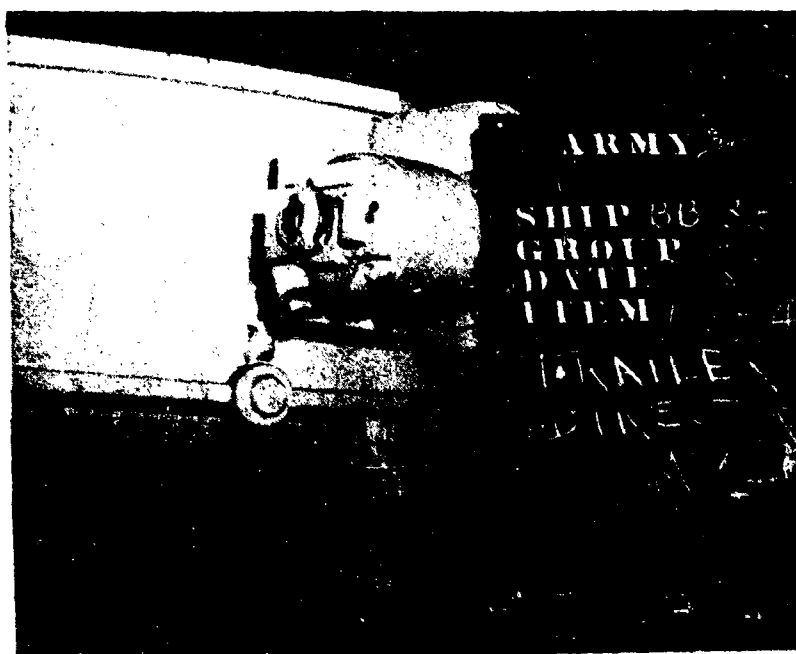
(5) Trailer M14 - The blast entered through the rear doors bulging the sides and front. The front and left windows were shattered, see Fig. 173 and Fig. 174. The left rear door window was cracked. The interior paneling was bulged outward and cracked, see Fig. 174 and Fig. 175. The blower was displaced causing the fan blades to bend in the housing.

Fig. 175 - USS Pennsylvania - Director, M9A2 - Interior view after Test Able showing the deformed inner paneling in trailer, M14.

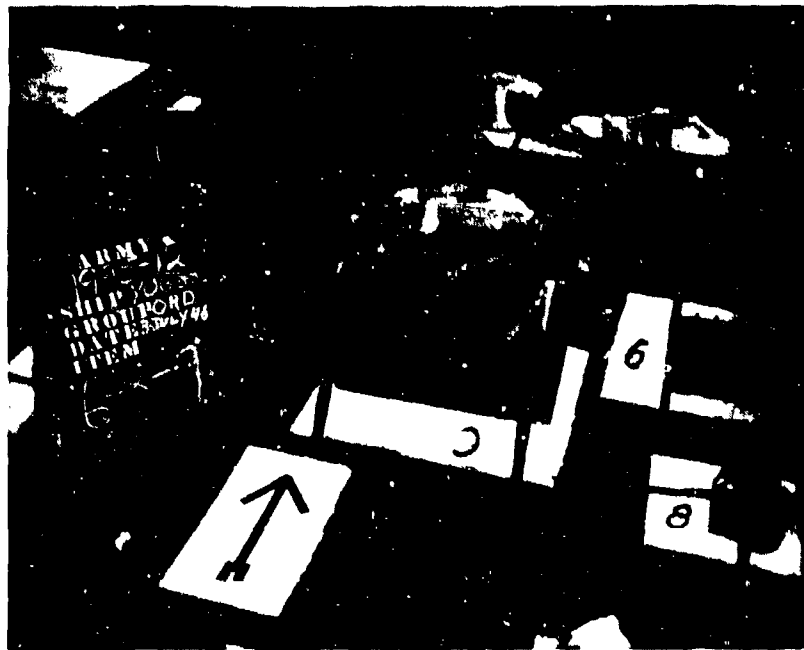
h. Cartridge, AP, Cal..50, M2 (Item #8). Ten rounds were displayed in a cardboard carton, Fig. 210, Fig. 212, and Fig. 211. On the YOG 83, prior to Test Able, the carton had fallen open due to rain. After the test, the tape used to hold the carton together was torn and scorched and the markings on the carton were burned off by the heat of the blast. The carton had been badly

Fig. 211 - YOG 83 - Damage to Items 6, 7, 8, and 9 after Test Able.

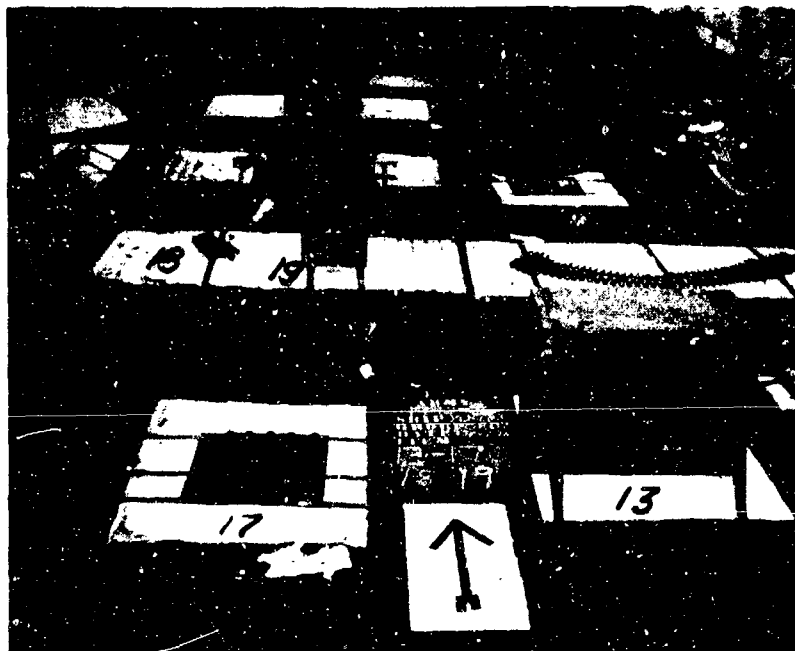
Fig. 216 - YOG 83 - Damage to Items 13, 17, 18, and 19, after Test Able.

q. Shell, Shotgun, 12-gauge, #8, C.S. (Paper) (Item #17). Ten rounds were displayed bare on a sheet metal plate, Fig. 222. On the YOG 83, Fig. 216, one layer of paper was scorched through on the right side of the shell. The scorch was about 3/8" wide for the length of the shells. On the LST 52, Fig. 223, the paper shells were distorted and scorched, and were unserviceable. The plate on which the items were displayed was bent up on the forward and after ends by the blast. On the re-

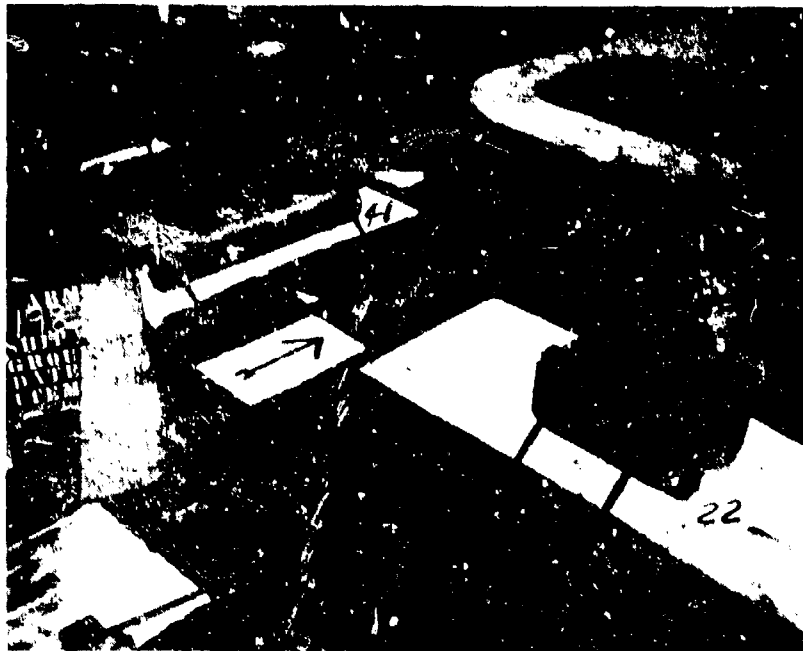
Fig. 229 - YOG 83 - Damage to Items 22 and 41 after Test Able.

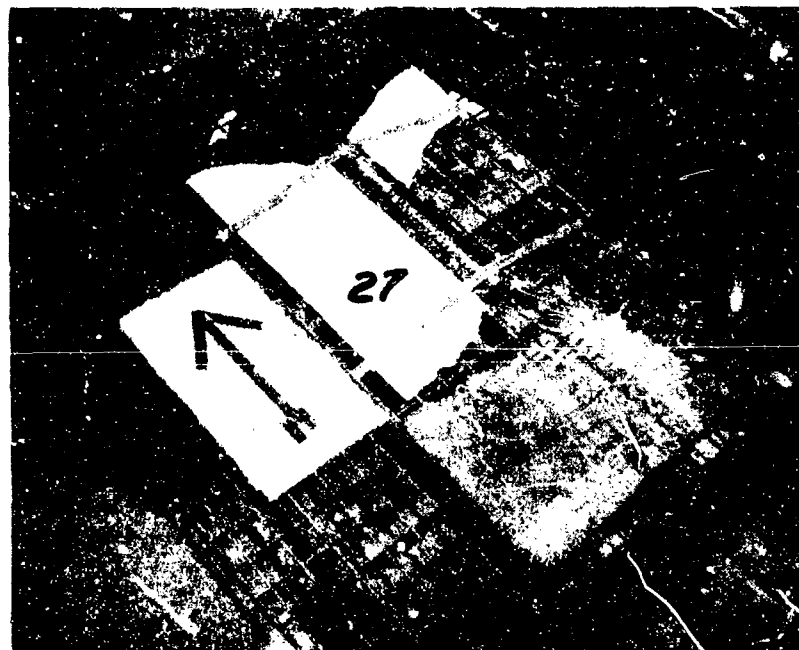
c. Cartridge, TP, M306 (T23) w/Fuse, Dummy, T126 for 57mm Rifle (Item #27). One cartridge was displayed here, Fig. 233. On the YOG 83, Fig. 234, the varnish on the cartridge case was softened by the sun. After Test Able the varnish had been scorched off the case on the side nearest the blast. The propellant had burned in the case but the primer had not functioned. It was impossible to determine if an internal change had taken place. Part of the paper liner was burned away on the side nearest the bomb explosion. The round did not change its position during the blast. The base of the cartridge case was not scorched. On the LST 52, Fig. 235 and Fig. 236, the propellant had also burned. The paper shell containing the propellant was approximately half burned away on the side facing the blast. The primer was still intact and showed no evidence of burning. On the LST 661, the paper liner of this case was scorched on the side directly exposed to the blast. One layer of paper liner was burned through in one place at the projectile end of the case. The powder charge was not exposed and apparently was not damaged. On the remaining ships, the LST 230 and LST 545, no damage was apparent.

Fig. 234 - YOG 83 - Damage to Item 27 after Test Able.

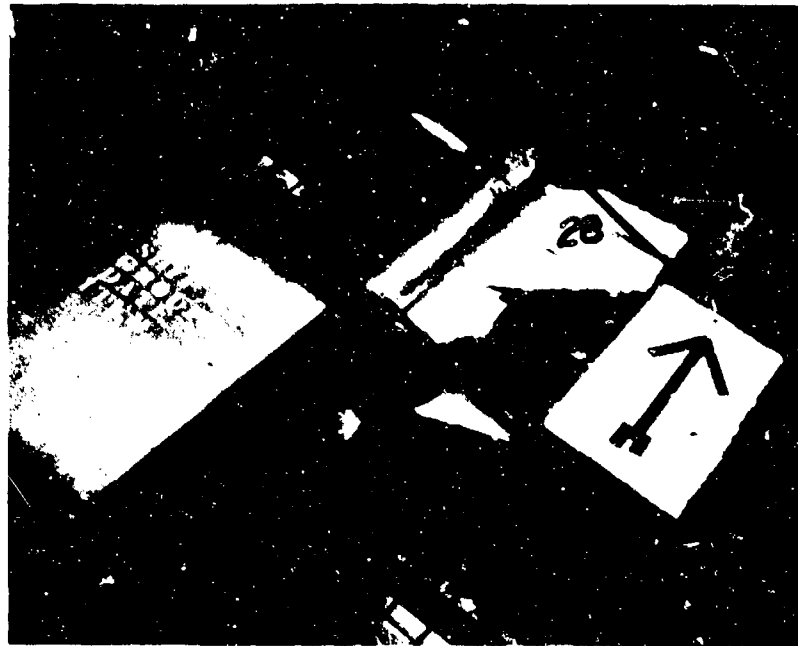
d. Cartridge, TP, M306 (T23) w/Fuse, Dummy, T126 for 57mm Rifle (Item #28). One round was displayed in a metal container, see Fig. 237. On the YOG 83, Fig. 238 and Fig. 239, the paint on this item was scorched off on the side facing the blast. It appeared to have been partially scorched and partially blown off. The model

Fig. 239 - YOG 83 - Damage to Item 28 after Test Able.

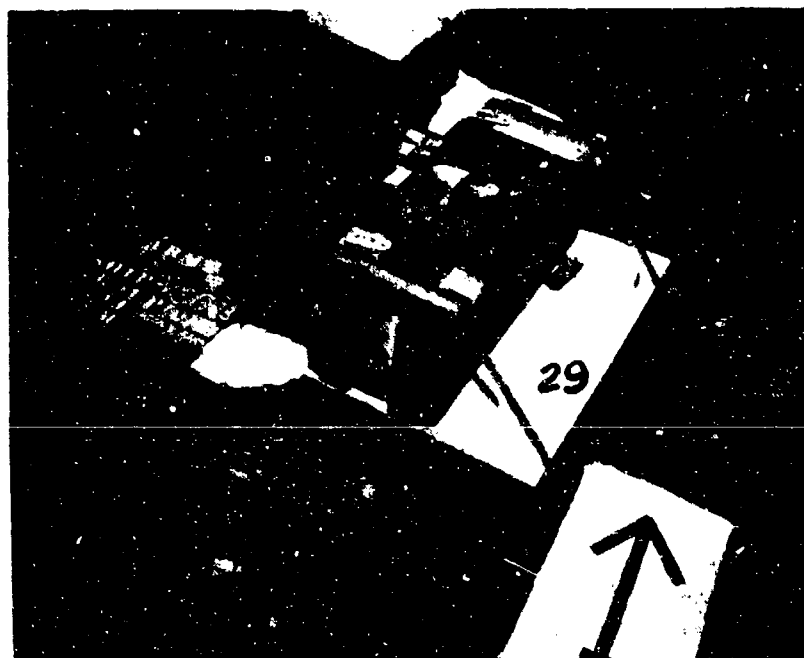
2. Cartridge, TP, M306 (T22) w/Fuse, Dummy, T126 for 57mm Rifle (Item #29). Two rounds were displayed in their wooden box, Fig. 241. On the YOG 83, Fig. 242, the box was displaced 1/2" by the blast. The wood was scorched and slightly charred on the exposed sides and the top. The rope handle was also scorched. The nomenclature was too badly scorched to be legible on the end of the box. This box had been restencilled before display and the old nomenclature was showing through the new on the side away from the blast. The hardware was corroded and scorched on the right side. The ammunition was apparently in good condition inside the box. On the LST 52, the box was scorched on the blast side. On the LST 661, the box was slightly scorched but the markings remained legible. This item was partially masked toward the bow on the LST 661. On the remaining two vessels, there was no apparent damage.

Fig. 242 - YOG 83 - View of scorched and charred surfaces of Item 29 after Test Able.

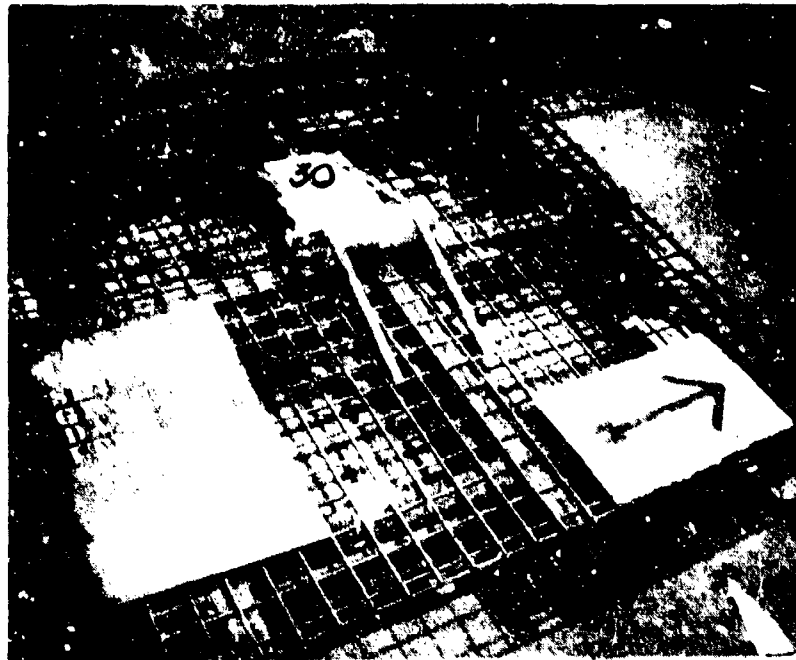
3. Shell, HE (1t) M43A1, w/o Fuse, 81mm Mortar, (Item #30). One round was displayed here, see Fig. 243. On the YOG 83, Fig. 244 and Fig. 245, the nose plug and adapter were rusty before Test Able. The powder increments had broken down under the sun and sea water. The increments on the right side were ignited by the bomb burst. Those on the left side were blown away. The ignition cartridge was still serviceable. The wire clips for the increments were in place but scorched. A small piece of one increment was still in position under one clip. The round was moved to the left 1/8" and the base moved 1" to the right of the old position. The shell body was slightly rusted, but the marking was in good condition. On the LST 52, Fig. 246, the propellant was destroyed. The primer was intact and the ignition cartridge had functioned. The cardboard container was slightly scorched. The clips holding the propelling charges had rusted before Test Able. On the LST 661, the increments had burned, apparently having been ignited by heat from the bomb, but the ignition cartridge was undamaged by either the blast or the burning of the increments. On the LST 220 and the LST 545, there was no apparent damage.

Fig. 245-YOG 83 - Damage to Item 30 after Test Able.

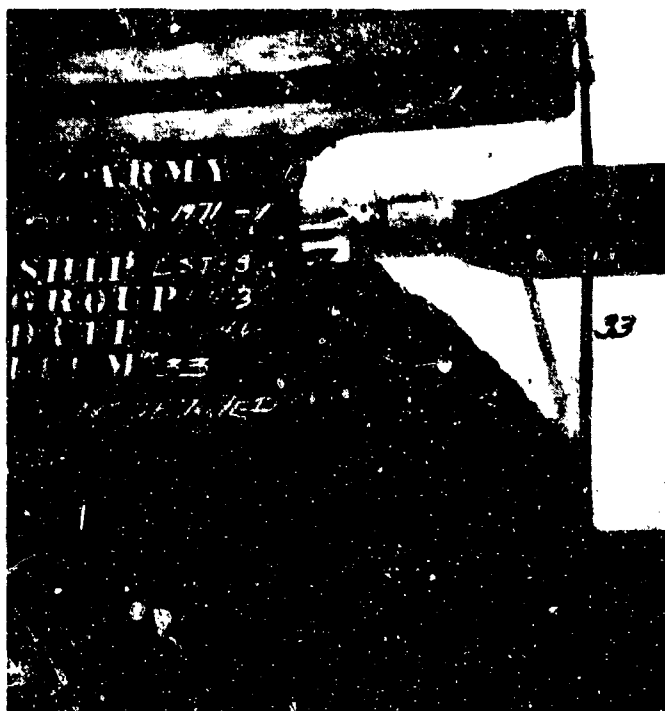
Fig. 251 - LST 52 - View of Item 33
after Test Able, showing
destruction of propellant.

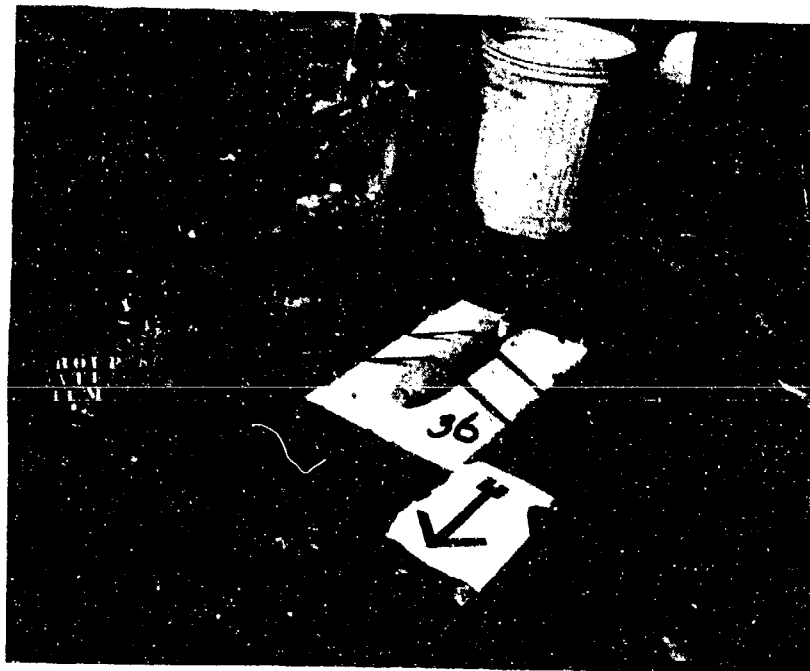
l. Shell, Smoke, WP, M57, w/o Fuse, 81mm Mortar (Item #36). One shell was displayed bare, see Fig. 253. On the YOG 83, Fig. 254, before Test Able, the powder increments had broken down from sun and rain. On Able day, they were ignited. The holding clips were rusted and distorted and the fins were rusted. The ignition cartridge was serviceable. This item was probably protected by the boat deck. On the LST 52, Fig. 255, the propellant was ignited and the cardboard container slightly scorched. The primer and ignition cartridge had not functioned. The propellant clip was rusty. The round was scorched on the nose and top, apparently from the combustion of a nearby 155 mm propelling charge. On the LST 661, the propellant increments were ignited by the heat from the bomb but the ignition cartridge and percussion primer were not damaged. On the LST's 220 and 545, no damage was apparent.

Fig. 254 - YOG 83 - Item 36 after Test Able.

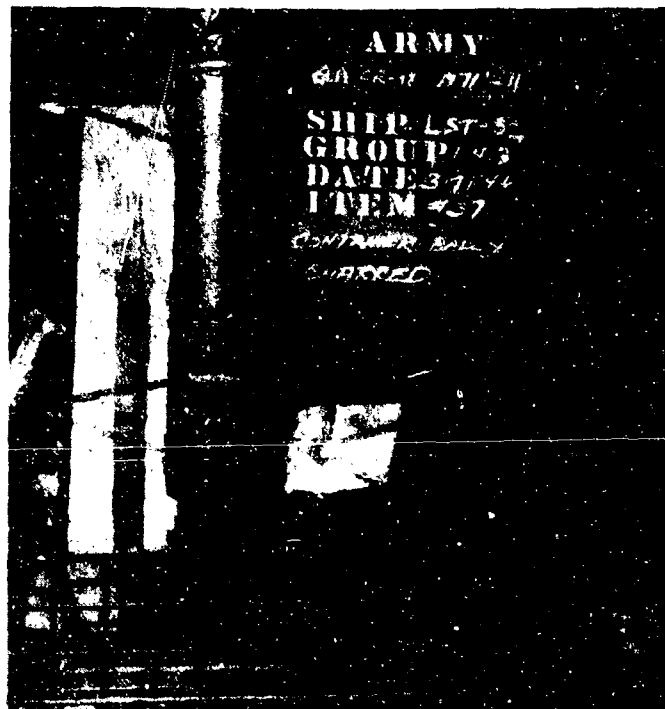
Fig. 258 - LST 52 - View of the charred container of Item 37 after Test Able.

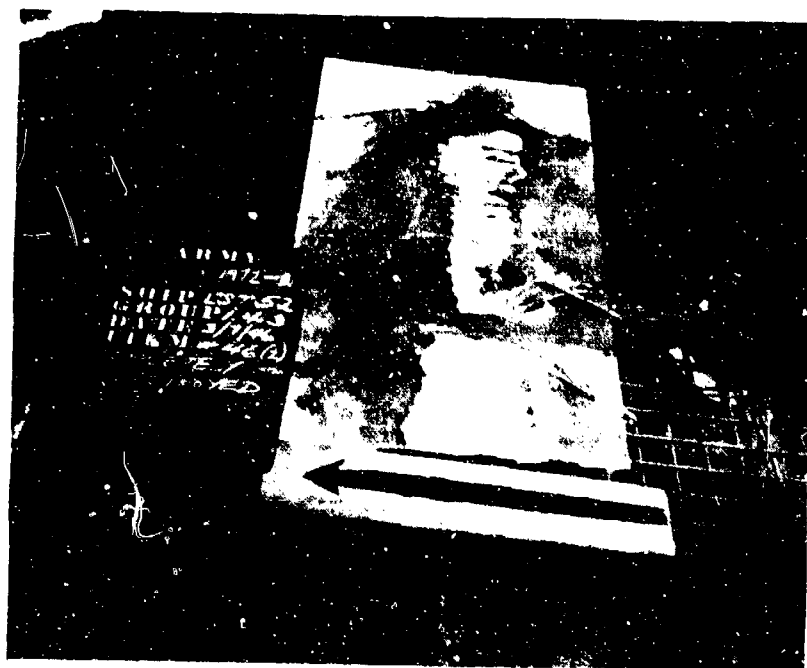
Fig. 275 - LST 52 - View after Test Able
showing the destruction of Item 46.

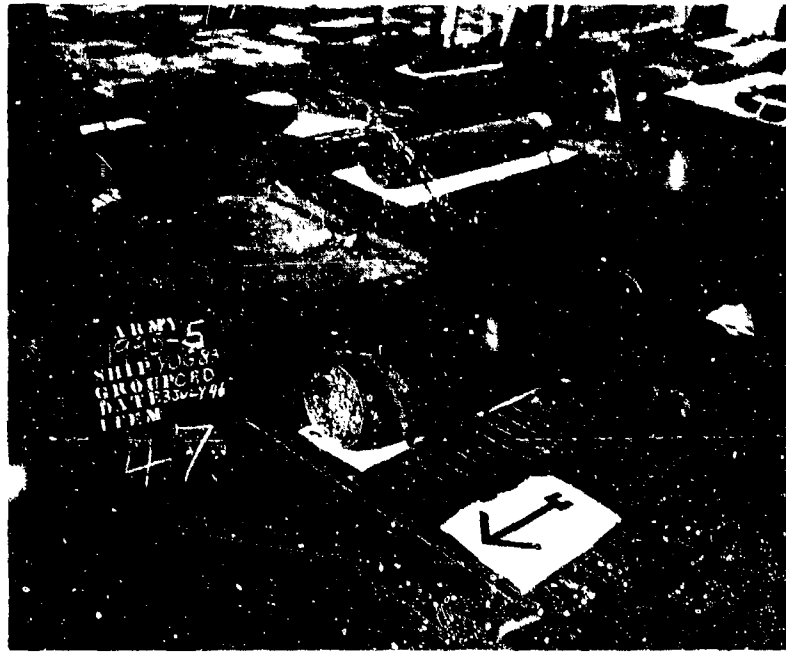
Fig. 277 - YOG 93 - View of the charred fiber container of Item 47 after Test Able.

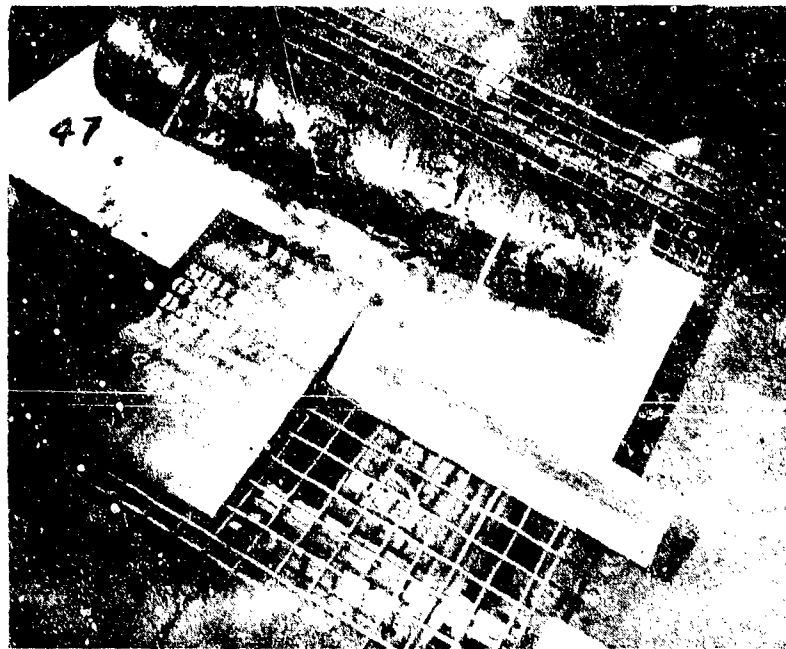
Fig. 278 - LST 52 - Damage to Item 47 after Test Able.

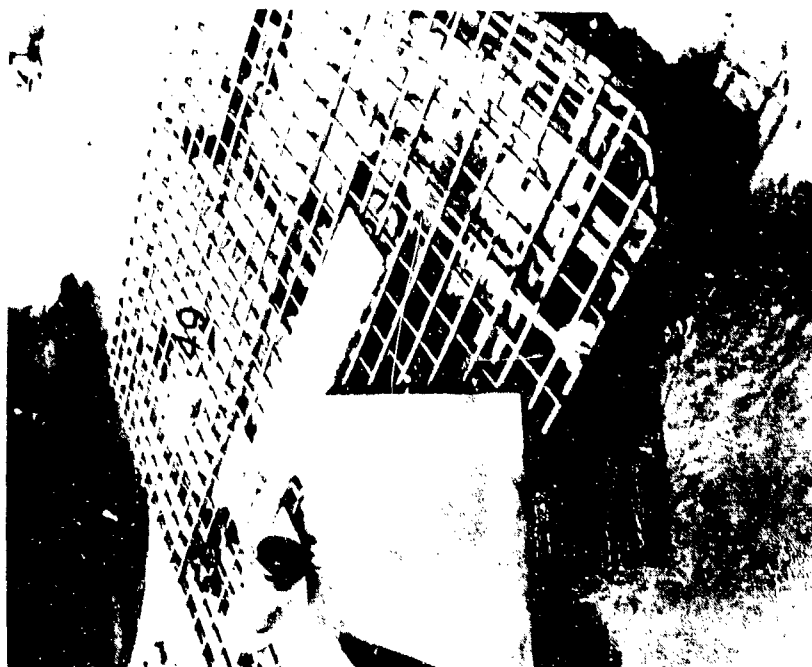
a. Fuse, T.M., M43A3, w/Booster, M20A1 (Item #49). One fuze was displayed bare on a sheet metal plate. Fig. 280. On the YOG 83, the fuze was slightly corroded. No visible damage was done by the bomb. On the LST 52, the item was displaced 29" forward but suffered no damage, Fig. 281 and 282. No damage was apparent on any other target ship.

Fig. 282 - LST 52 - Items 49 and 50
after Test Able.
